# Manhole Inspection Summary

# Manhole # S25G\_\_045MH

Insp Date: **1/13/09 12:52 PM**

**Location** Address: **5 CARROLLTON-STOCKTON-ALLEY**

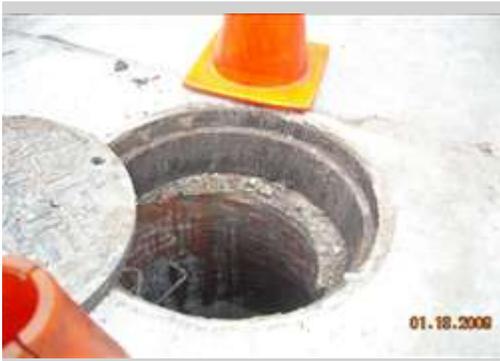
MISC.

INFLOW EVIDENCE FROM SHEETING

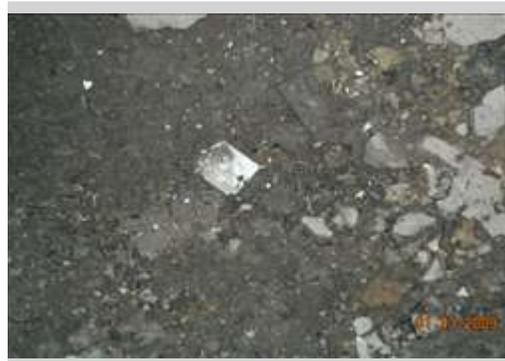
Defect 2

Condition:  Sound  Cracked  Root Intrusion  Deteriorated  Leaks  **Debris**

DEBRIS IN TERMINAL CHANNEL

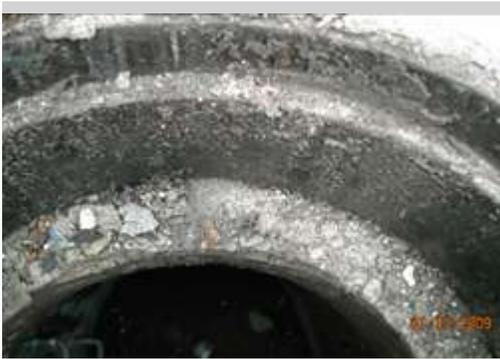
Defect 1

Offset: **3** (in.)

FRAME OFFSET

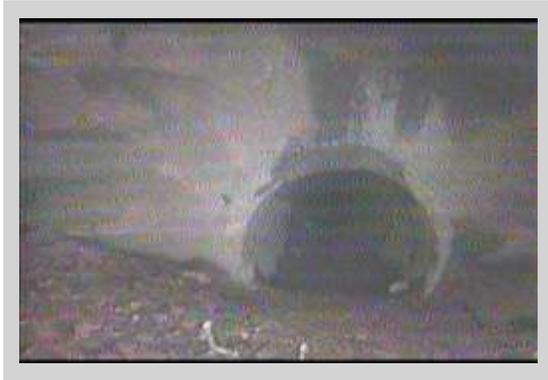
12 O'Clock Outflow

8 in. Circular Gravity Sewer  
Pipe Out @ 12 O'Clock

Deposits:  None  **Mud**  Sludge  Debris  Grease

Silt Depth: **1** (in.) Deposits Extent: **Light**

Infiltration: **Evidence** Pipe Seal Cond: **Sound**
